ONONDAGA DAM
NEW YORK
INVENTORY No. NY 794

PHASE I INSPECTION REPORT
NATIONAL DAM SAFETY PROGRAM

PHASE I INSPECTION REPORT
ONONDAGA DAM I.D. NO NY 794
OSWEGO RIVER BASIN
ONONDAGA COUNTY, NEW YORK

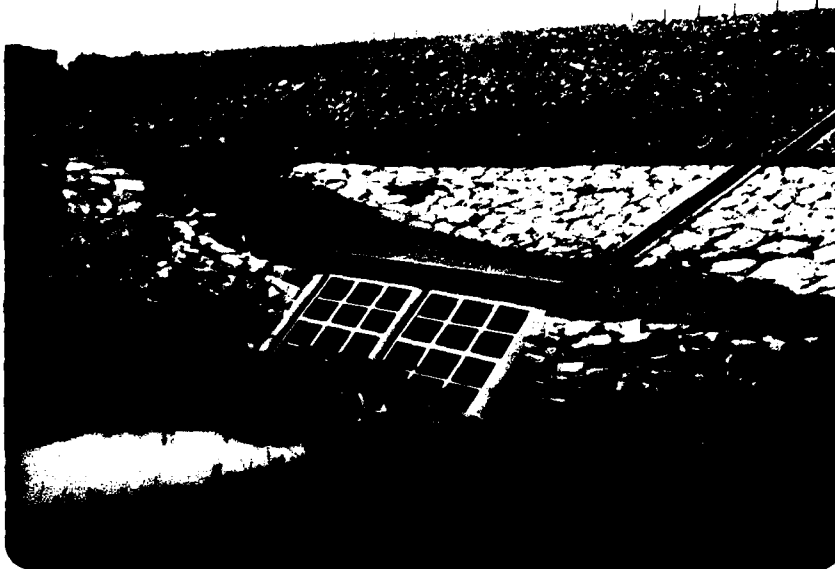
7. Inlet to reservoir
drain.

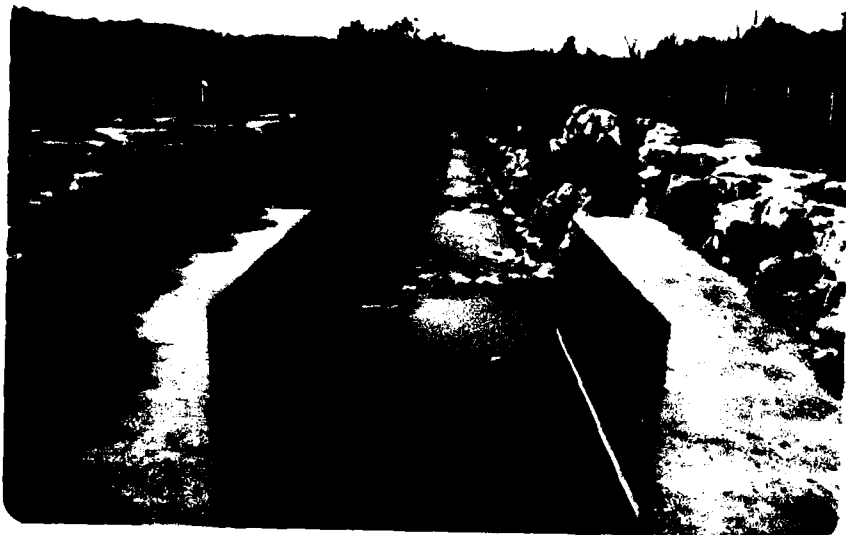
10. Reservoir drain
outlet channel,
looking downstream.
